Carbon Fiber Strengthening of Masonry Walls

Albert N. Parlin School – Everett, MA

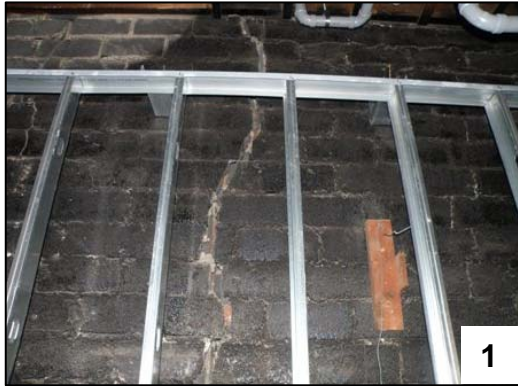
Photo 1: Routine construction had exposed failed, separated masonry in the interior brick walls on two levels of the Parlin school.
