PROJECT PROFILE:

393 Commonwealth Avenue - Boston, MA

THE ALPHA SOLUTION: The Alpha team performed several services to protect and preserve the prominent Back Bay Brownstone building at 393 Commonwealth Avenue in Boston, MA.

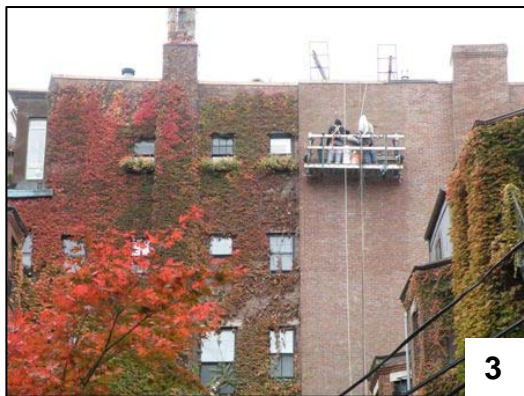
SIDE ELEVATION (Photo 2)

A vine growth covered the side elevation with many roots 2-3 inches in diameter, which kept the masonry constantly damp.

To restore the masonry to like-new condition, the Alpha team removed the mortar and repointed the brick masonry.

Alpha also replaced masonry on the upper 15 feet of the wall damaged from the vines.
